Recreational Use Attainability Analysis of Five Creeks along the Little Brazos River: Walnut Creek (1242O), Mud Creek (1242K), Pin Oak Creek (1242L), Spring Creek (1242M), and Campbells Creek (1242I)

Prepared for:
Texas State Soil and Water Conservation Board
Project 08-54

Data Collected by:
Brazos River Authority

June 2014

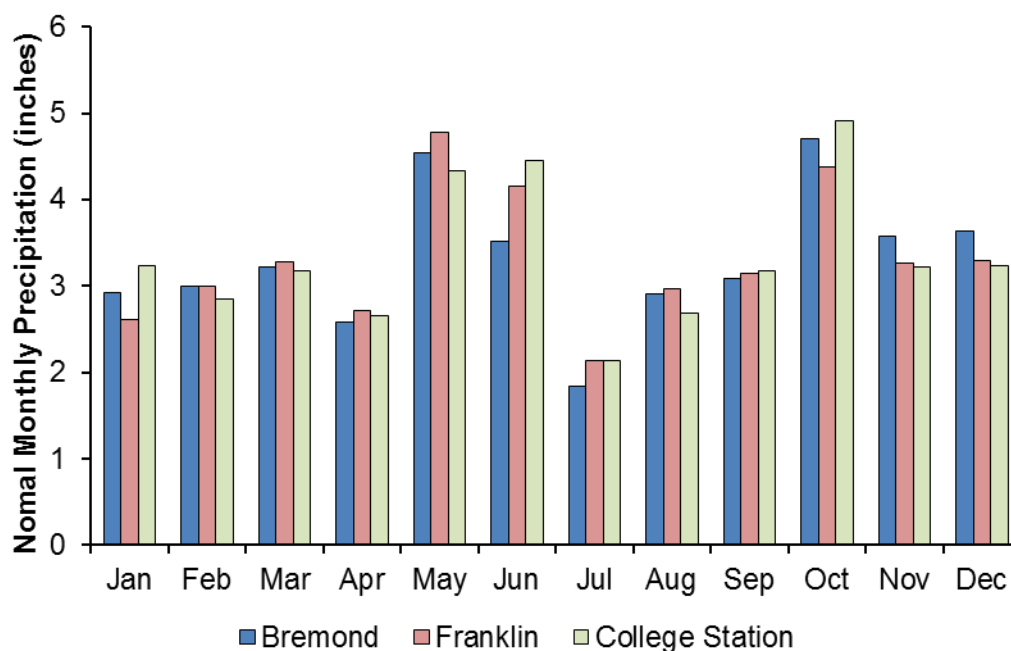
Figure 2.1 Monthly average precipitation for Bremond, Franklin, and College Station, Texas.

Annual precipitation for the area averages about 40 inches based on long-term data for Bremond, Franklin and College Station, Texas (NOAA, 2013). Peak rainfall months tend to be May, June, and October with over four inches on average occurring in each month (Figure 2.1). The lowest rainfall generally occurs in July with only about two inches. Snowfall accumulations are limited (often in tenths of inches) but do occur in the winter months of December, January, and February.

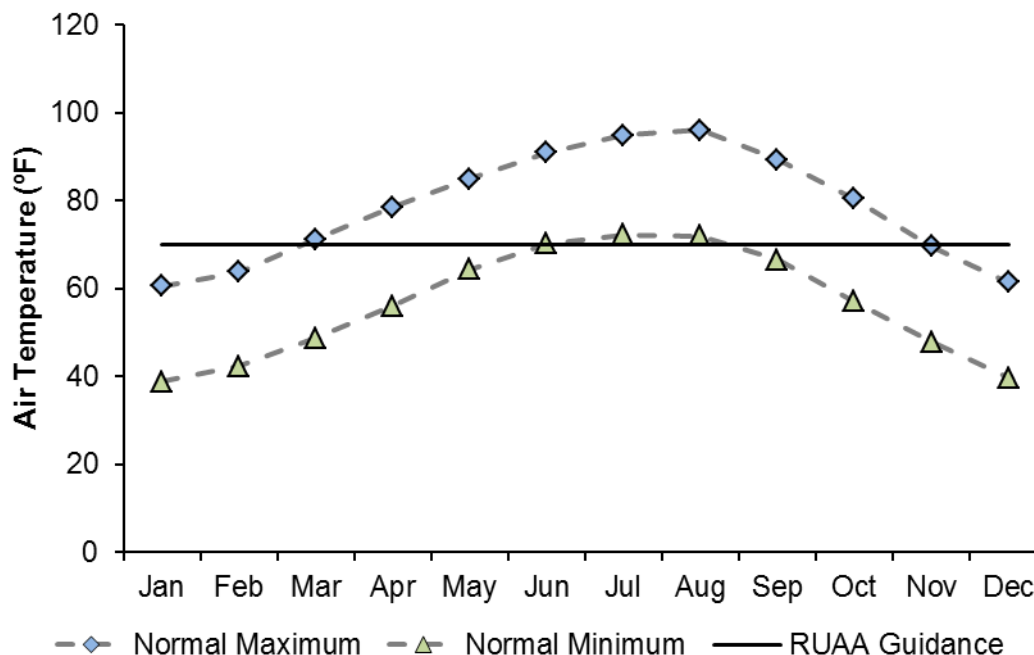
Figure 2.2 Monthly normal maximum and minimum air temperatures for Franklin, Texas compared to RUAAs guidance for field surveys.

With regard to temperatures, average maximum temperatures for Franklin, Texas ascend above 70° F (21° C) beginning in March and continuing through November (Figure 2.2). March through October are the months noted as generally suitable for assessing recreational use, but only if temperatures reach above 70° F (TCEQ, 2009).

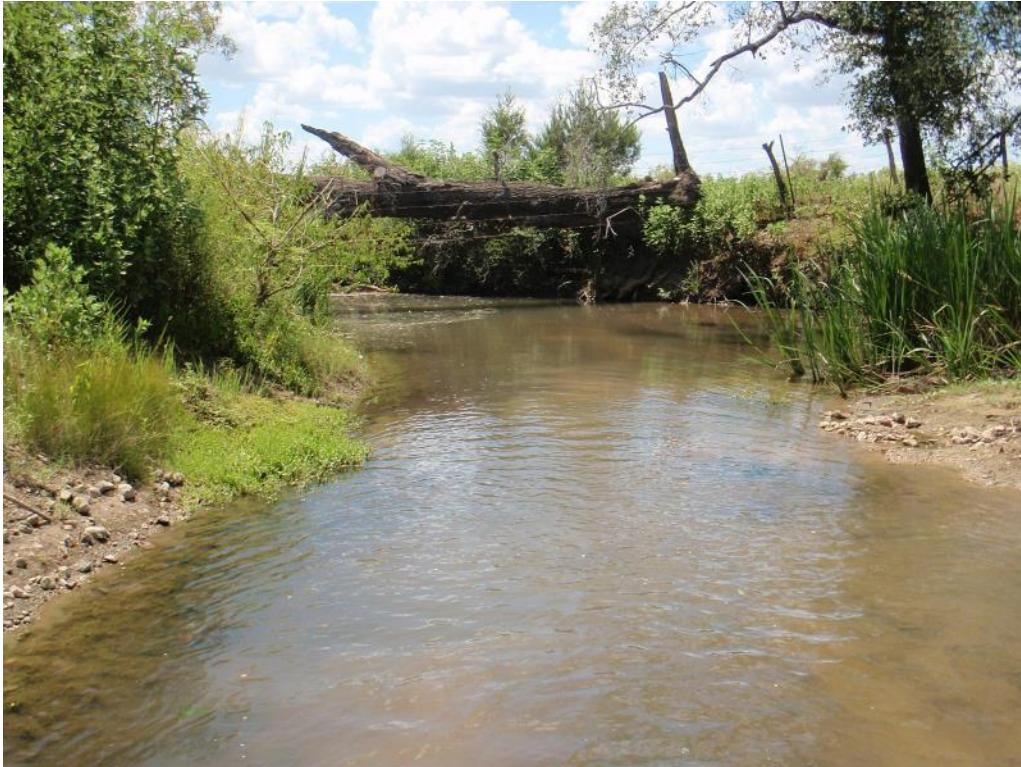
Figure 4.2 Photograph of Walnut Creek Site 16403 taken on August 10, 2010, the downstream view of the 30-m transect showing the gentle slopes and private property fence.

Walnut Creek at Site 16403 was visited on August 10 and 16, 2010. This site, located north of Calvert, Texas in Robertson County, was only accessible to the public in the area of the bridge crossing State Highway 6 for about 50 meters. The remainder of the study reach was located on private lands that were fenced. The site is located in a pasture dominated corridor with a few trees and shrubs spread throughout the reach (Table 4.6). At the site, access to the stream was easy with gentle slopes and the lack of dense vegetation (Table 4.7). Figures 4.2 and 4.3 depict the appearance of the site during each of the surveys.

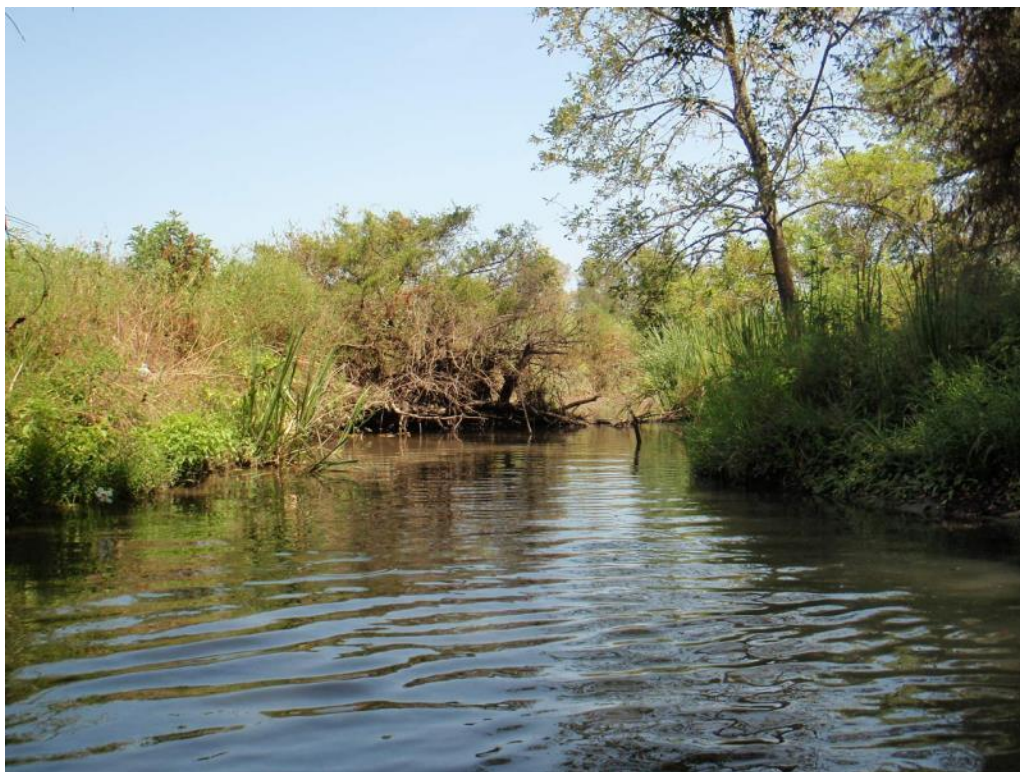
Figure 4.3 Photograph of Walnut Creek Site 16403 taken on August 16, 2010, the downstream view of the 150-m transect.

Site 16403 was wadeable for the entire 300-m reach length. During both surveys in August, the shallow water, average thalweg of 0.58 meters, and the sandy substrate made for easy wading. Stream widths ranged from 11 m to 0.8 m during both surveys with a normal flow status (Tables 4.8 and 4.9). Four pools were identified during each trip and their dimensions are shown in Tables 4.12 and 4.13. One tree obstruction was observed near the 150-m transect as shown in Figure 4.3.

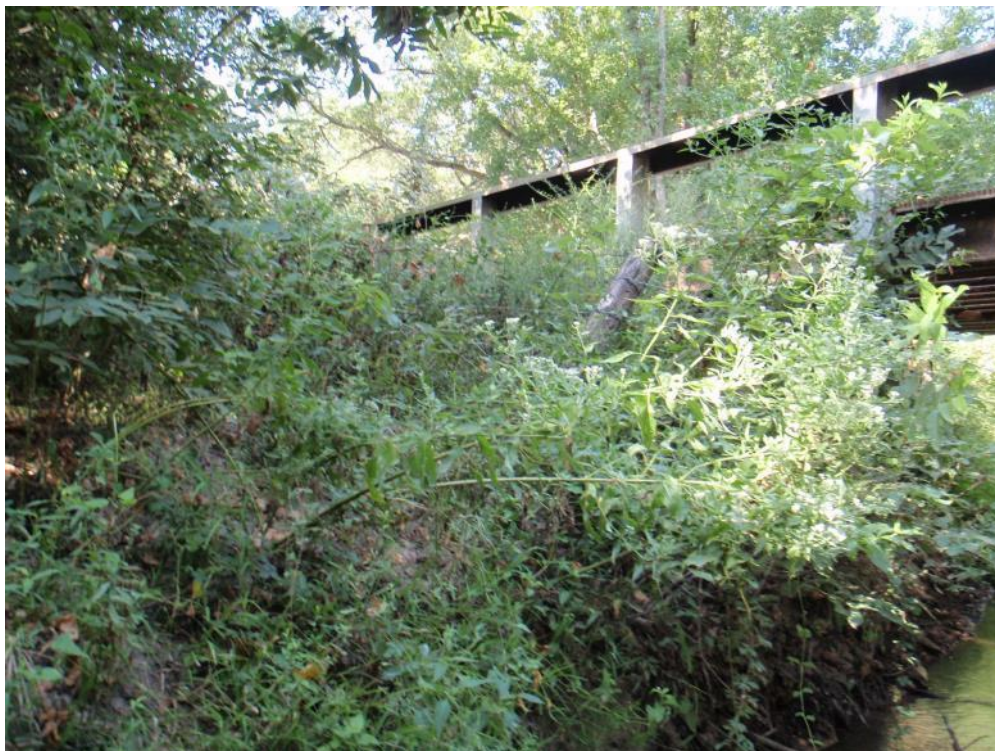
Figure 4.4 Photograph of Walnut Creek Site 20021 taken on August 16, 2010, showing the limited public accessibility at the road crossing.

Walnut Creek at site 20021 was visited on June 22 and August 16, 2010. This site, located north of Calvert, Texas in Robertson County, was accessible through private lands that were fenced from County Road 123. Although the site is listed as being publically accessible, access is very limited due to the property fences and dense vegetation at the bridge crossing (Figure 4.4). The corridor along the stream was forest dominated with a natural stream appearance (Table 4.6). Access to the stream was moderately difficult as BRA personnel traversed the property fence and thick vegetation to reach the stream (Table 4.7). Figures 4.4 and 4.5 depict the public accessibility at the road crossing and the appearance of the site during each of the surveys.

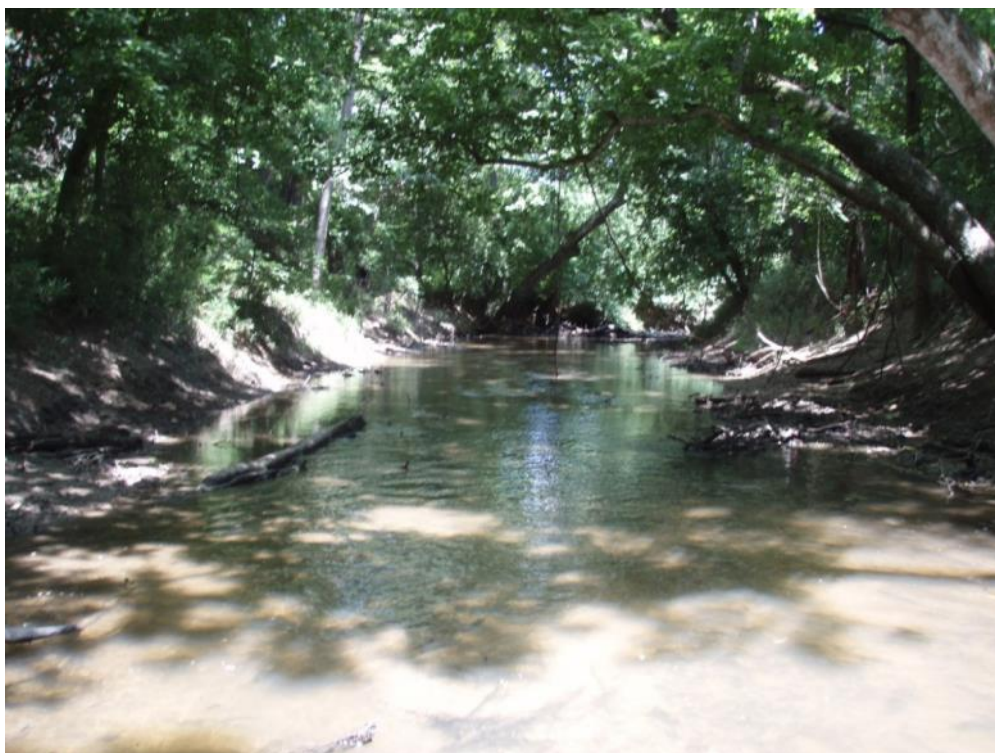
Figure 4.5 Photograph of Walnut Creek Site 20021 taken on June 22, 2010, the downstream view of the 300-m transect.

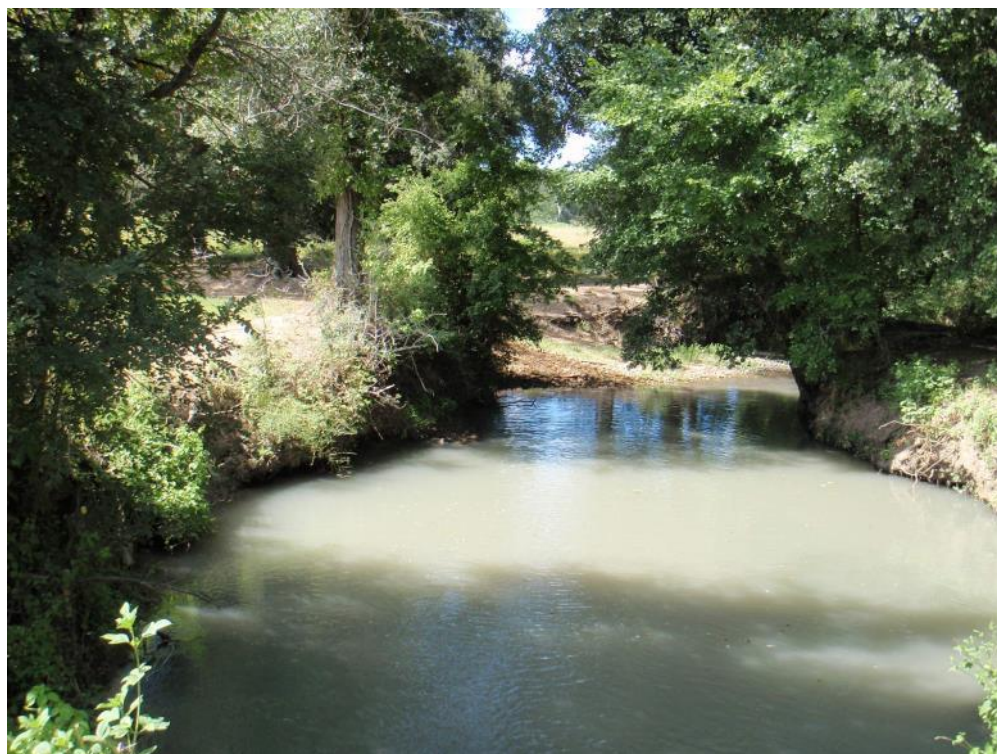
Figure 4.6 Photograph of Walnut Creek Site 99901 taken on August 10, 2010 showing a large pool and an entry point into the stream.

Walnut Creek at Site 99901 was visited on August 10 and 23, 2010. This site, located north of Calvert, Texas in Robertson County, was accessible only through private lands that were gated and fenced with a cattle guard at the property entrance. With landowner permission, BRA personnel entered private property and drove approximately three miles through pasture land to reach the site. The site is located in a pasture dominated corridor (Table 4.6) and is downstream of a mining operation that discharges water into Walnut Creek. At the site of the 0-m transect, access to the stream was easy, although other locations throughout the reach provided more difficult access into the stream due to steep banks. Figures 4.6 and 4.7 depict the appearance of the site during each of the surveys.

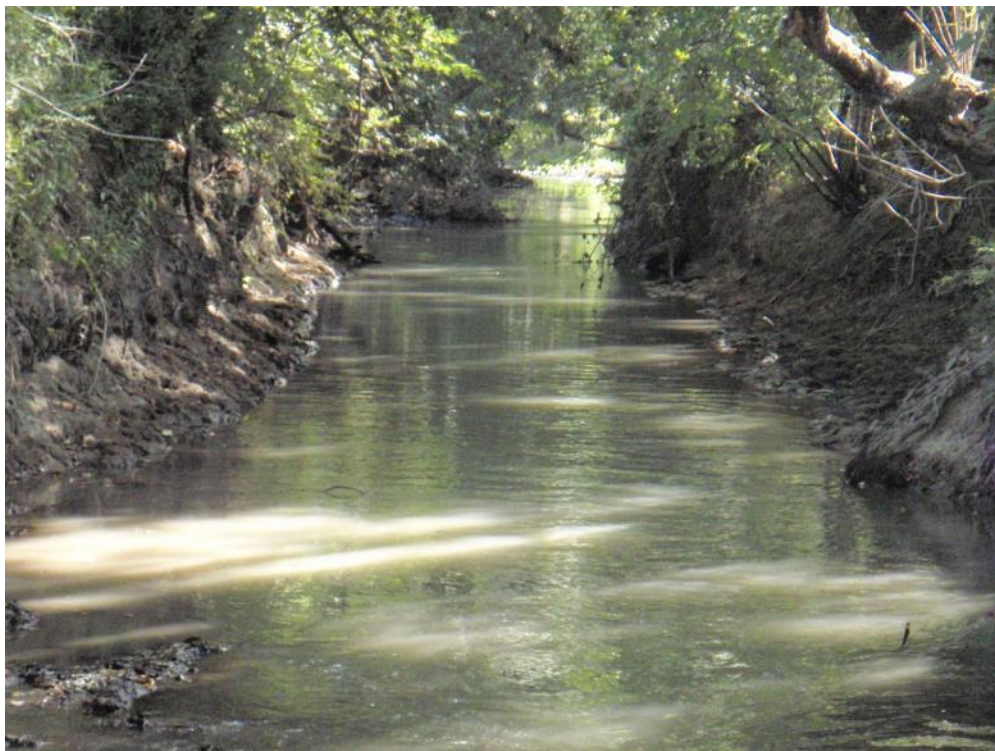
Figure 4.7 Photograph of Walnut Creek Site 99901 taken on August 23, 2010, the upstream view of the 150-m transect.

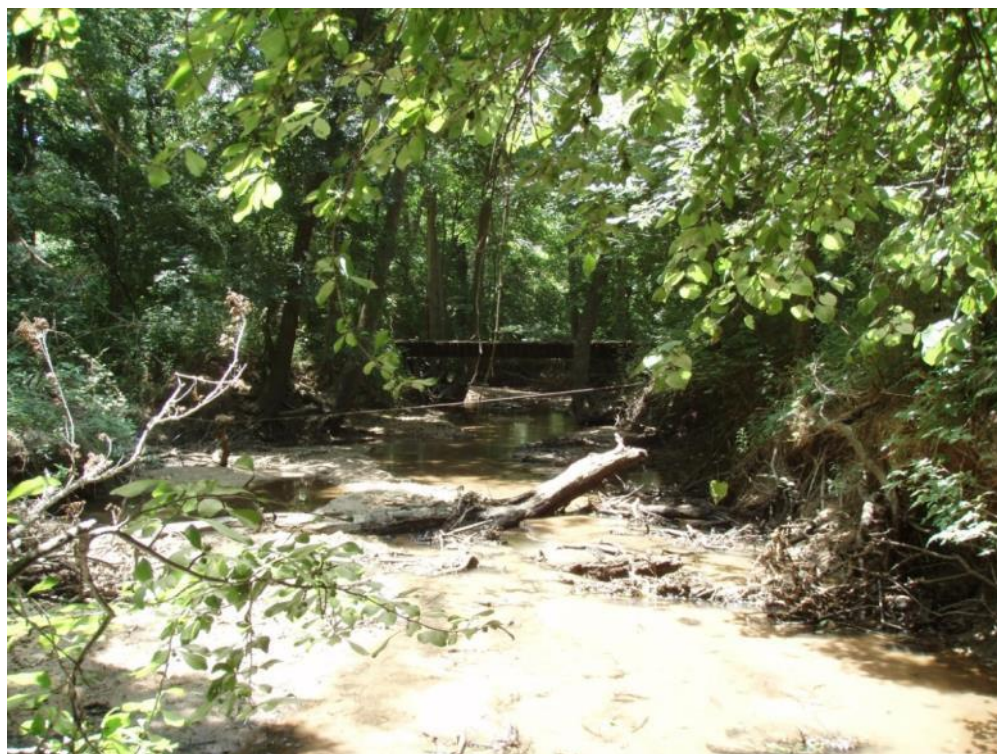
Figure 4.8 Photograph of Walnut Creek Site 20565 taken on June 22, 2010, the downstream view of the 30-m transect.

Walnut Creek at Site 20565 was visited on June 22 and August 16, 2010. This site, located northeast of Calvert, Texas in Robertson County, was only publically accessible at the bridge crossing Nesbit Road. With landowner permission, BRA personnel traversed over a posted private property fence onto private property to survey the 300-meter reach. The site is located in a pasture and forest dominated corridor (Table 4.6) with moderately easy access to the stream (Table 4.7). Figures 4.8 and 4.9 depict the appearance of the site during each of the surveys.

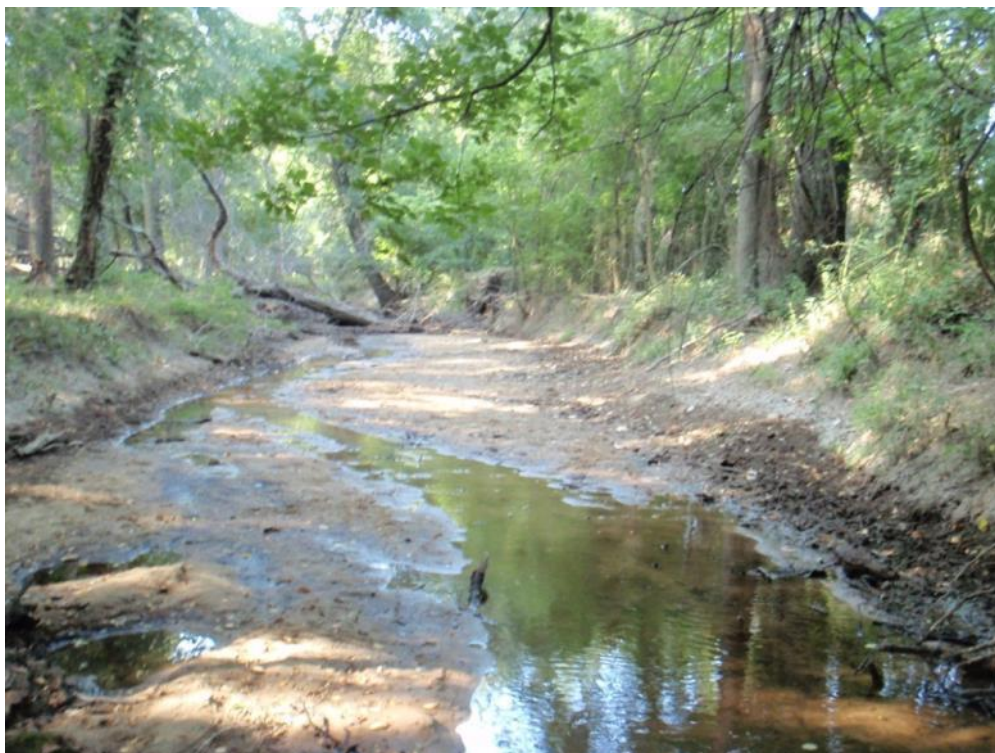
Figure 4.9 Photograph of Walnut Creek Site 20565 taken on August 16, 2010, the downstream view of the 300-m transect.

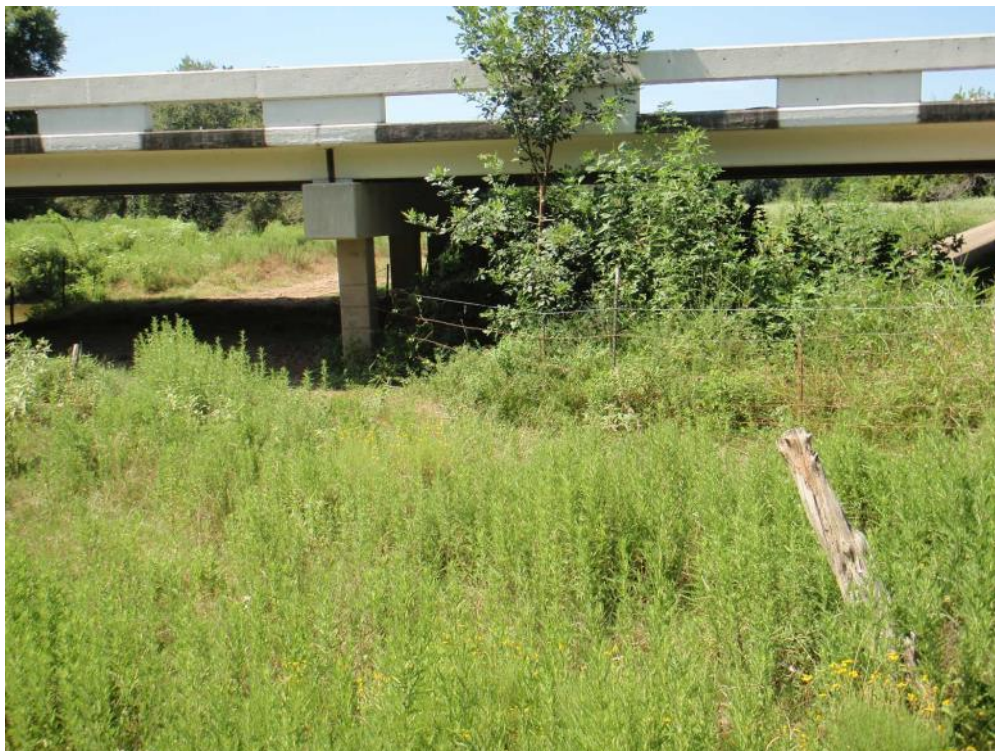
Figure 4.10 Photograph of Walnut Creek Site 99902 taken on August 13, 2010, showing very limited public access at the bridge crossing.

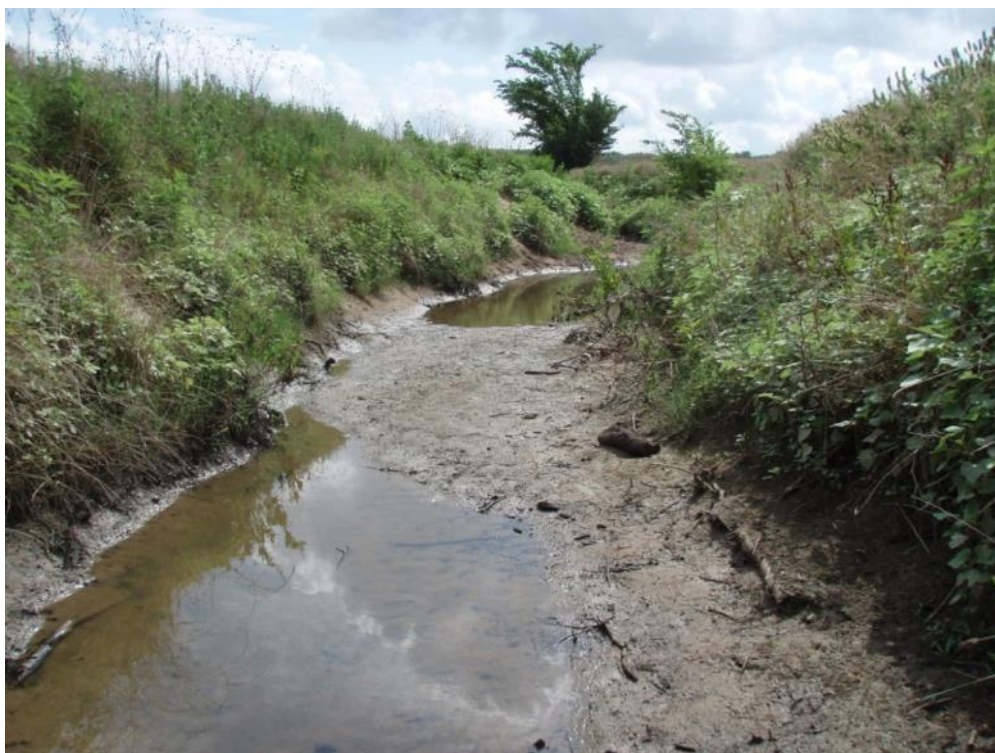
Figure 4.11 Photograph of Walnut Creek Site 99902 taken on June 24, 2010, the upstream view of the 300-m transect.

Walnut Creek at Site 99902 was visited on June 24 and August 13, 2010. This site, located northeast of Calvert, Texas in Robertson County, was only publicly accessible at the bridge crossing FM 46. Although the site is listed as being publicly accessible, private property fences severely hinder access to the creek as shown in Figure 4.10. The site is located in a pasture and shrub dominated corridor (Table 4.6). At the site, access to the stream was moderately easy due to the thick vegetation, property fence and moderate slopes (Table 4.7). Figures 4.11 and 4.12 depict the appearance of the site during each of the surveys.

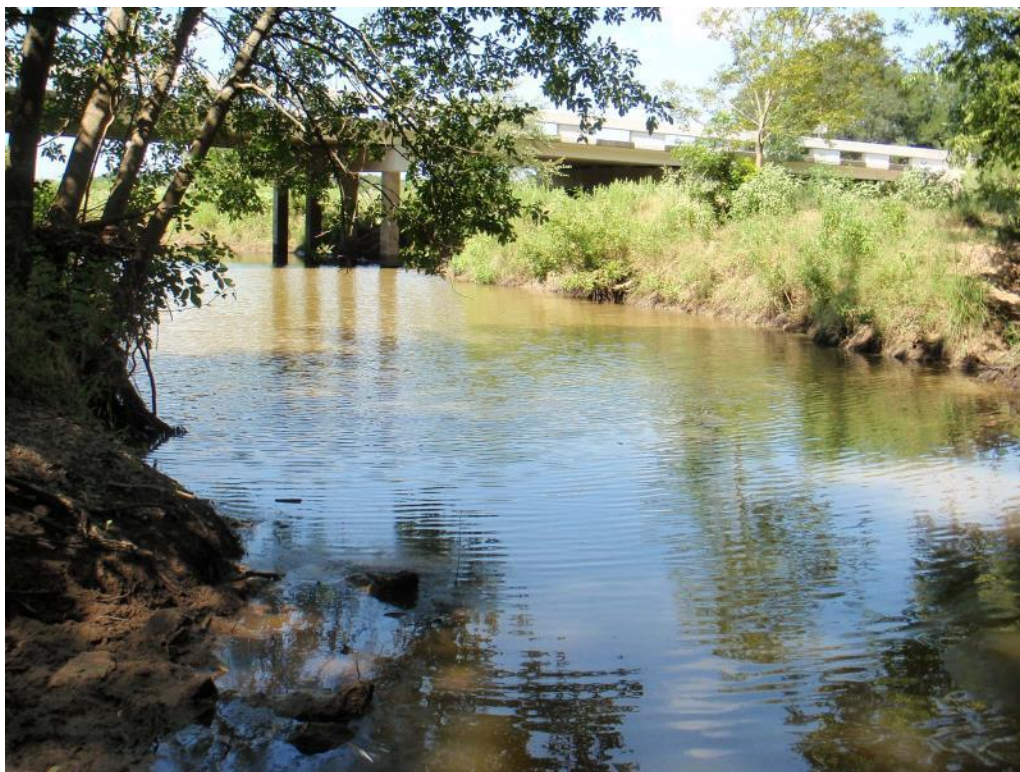
Figure 4.12 Photograph of Walnut Creek Site 99902 taken on August 13, 2010, the downstream view of the 30-m transect.

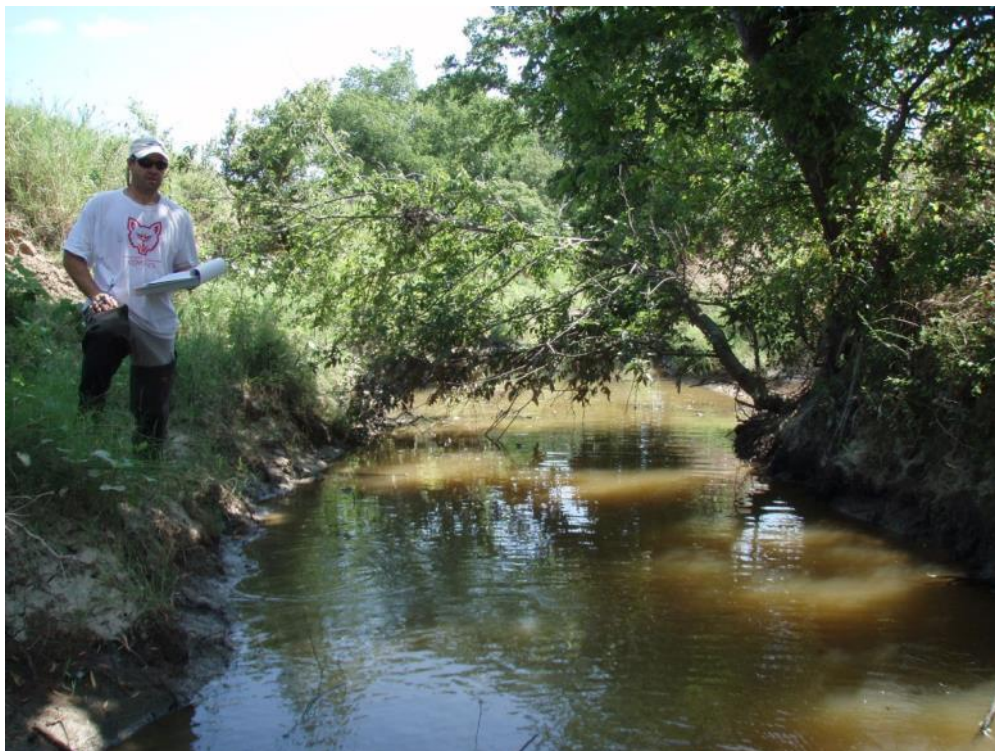
Figure 4.13 Photograph of Walnut Creek Site 99903 taken on June 22, 2010, the upstream view of the 150-m transect. BRA personnel in photograph.

Walnut Creek at site 99903 was visited on June 22 and August 13, 2010. This site, located northeast of Calvert, Texas in Robertson County, was publicly accessible only at the bridge crossing FM 2293. Although the site is listed as being publicly accessible, private property fences severely hinder access to the creek. The site is located in a pasture dominated corridor for the entire length of the reach (Table 4.6). At the site, access to the stream was easy (Table 4.7), although other locations within the reach had more challenging entrances due to steep banks, dense vegetation, and trees. Figures 4.13 and 4.14 depict the appearance of the site during each of the surveys.

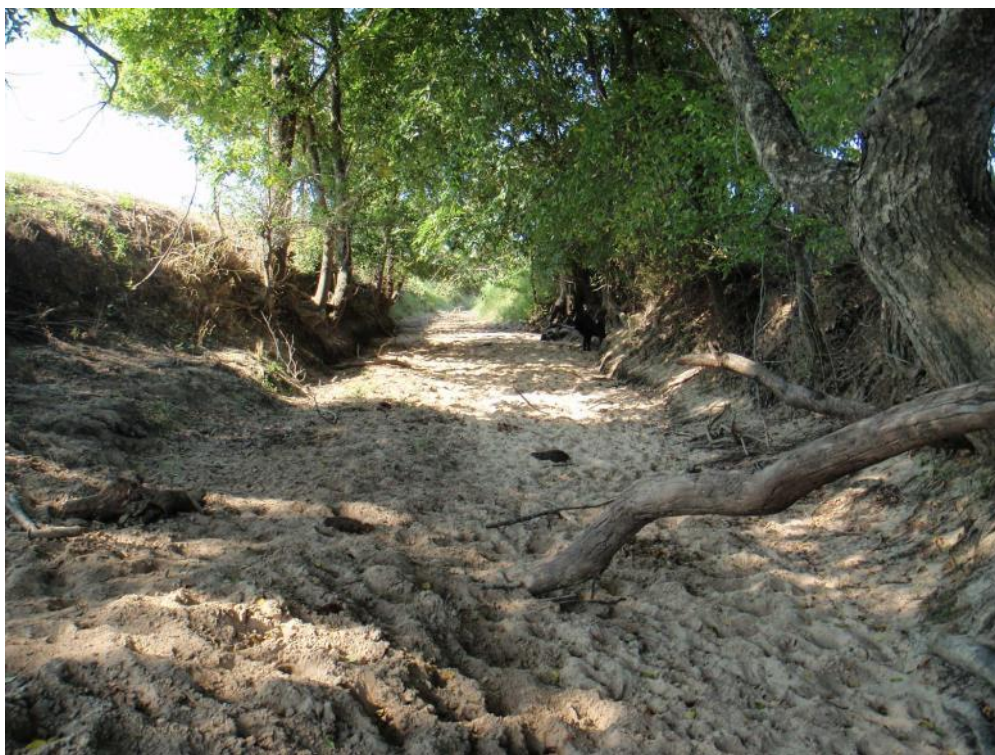
Figure 4.14 Photograph of Walnut Creek Site 99903 taken on August 13, 2010, the downstream view of the 30-m transect.

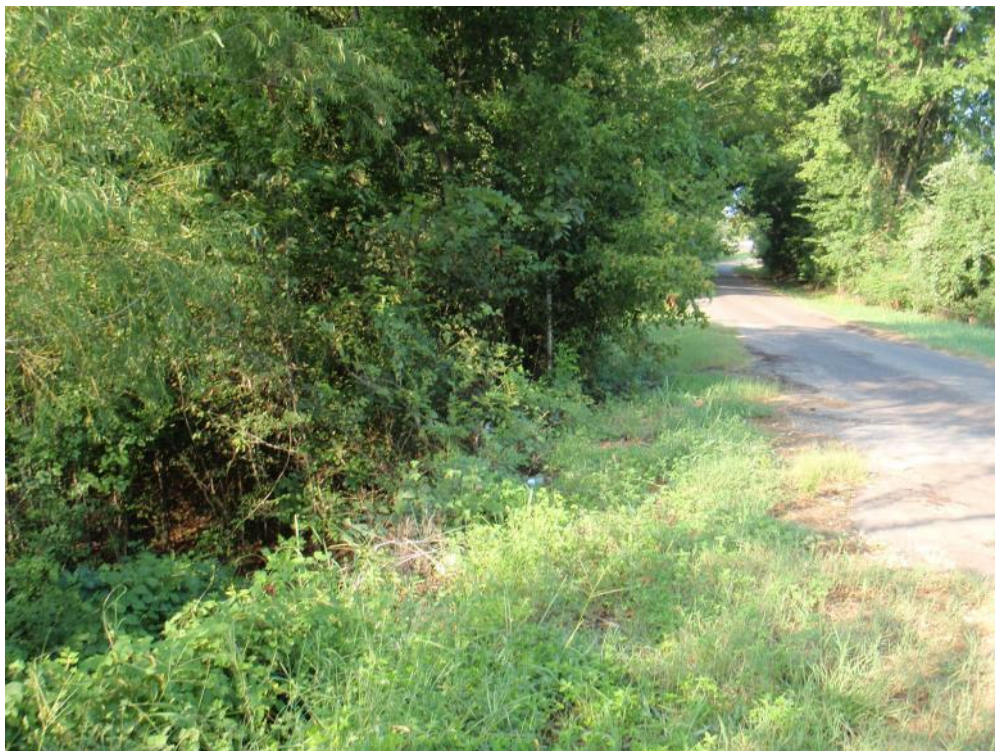
Figure 4.15 Photograph of Walnut Creek Site 99905 taken on August 13, 2010 showing limited public accessibility.

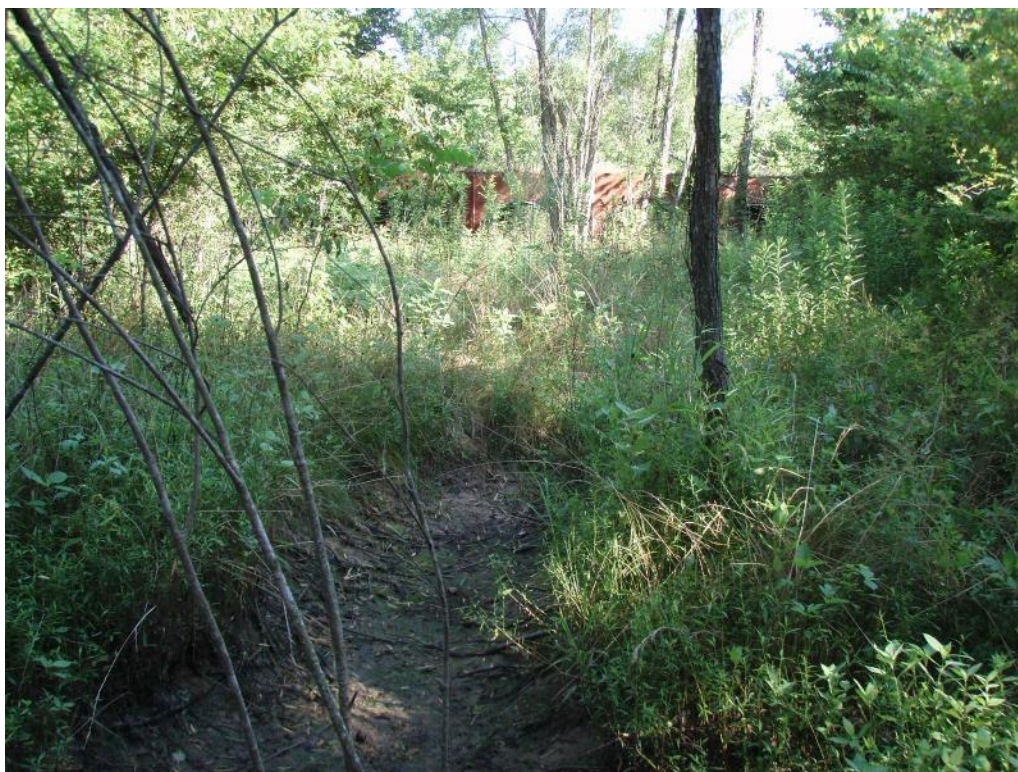
Figure 4.16 Photograph of Walnut Creek Site 99905 taken on June 22, 2010, the upstream view of the 30-m transect.

Walnut Creek at Site 99905 was visited on June 22 and August 13, 2010. This site, located northeast of Calvert, Texas in Robertson County, was publicly accessible only at the bridge crossing Wasik Road. Although the site is listed as being publicly accessible, private property fences overgrown with brush and thick vegetation limit public accessibility as depicted in Figure 4.15. BRA personnel entered private property through the brush and over the fence to reach the site. The site is located in a forest and shrub dominated corridor (Table 4.6). At the site, access to the stream was moderately difficult due to the thick vegetation (Table 4.7). Figures 4.16 and 4.17 depict the appearance of the site during each of the surveys.

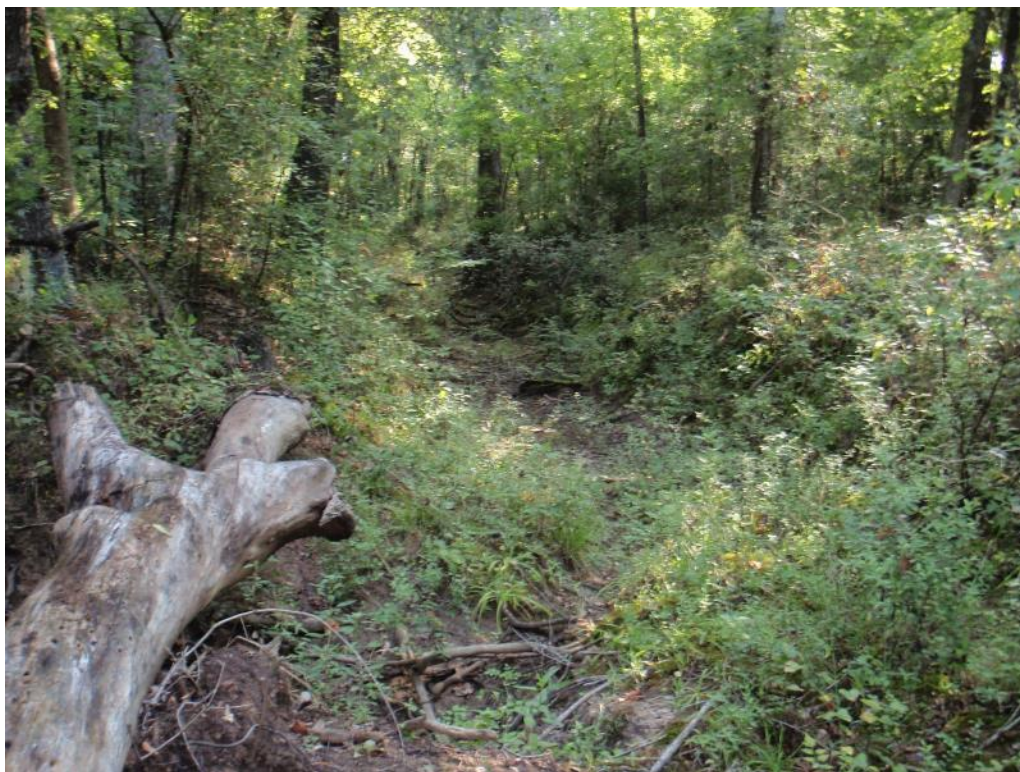
Figure 4.17 Photograph of Walnut Creek Site 99905 taken on August 13, 2010, the upstream view of the 300-m transect.

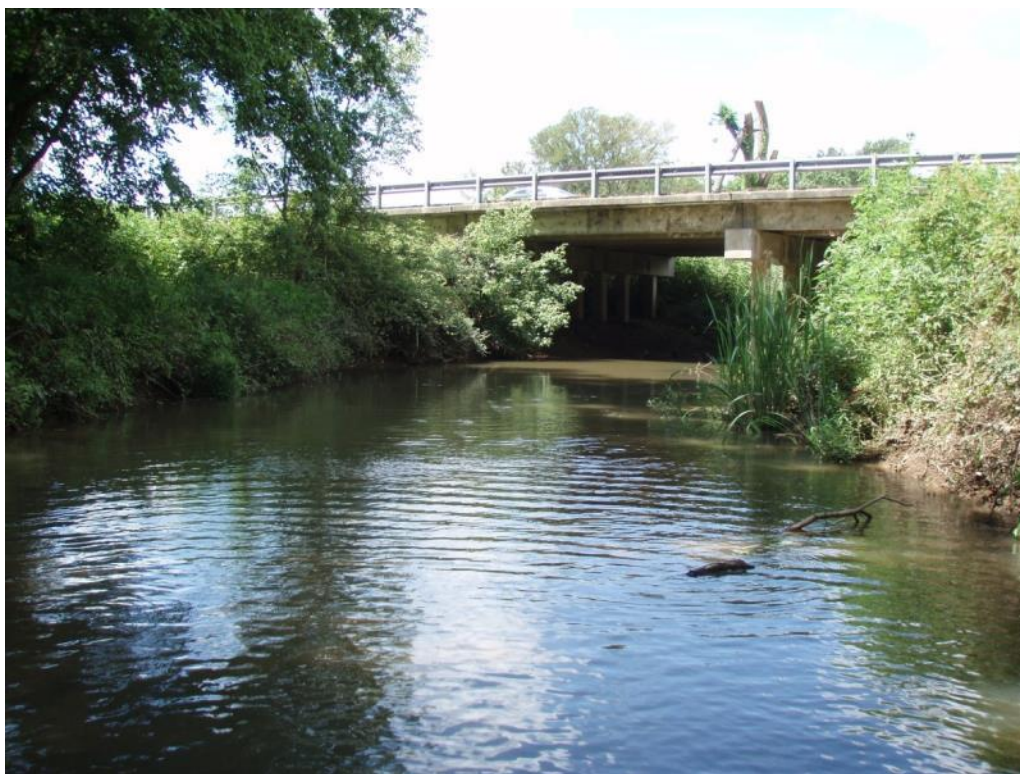
Figure 5.2 Photograph of Mud Creek Site 16402 taken on June 25, 2010, the downstream view of the 30-m transect.

Mud Creek at Site 16402 was visited on June 25 and August 27, 2010. This site, located on State Highway 6 approximately 4.5 miles northwest of Hearne, Texas, was accessible at the area immediately underneath the bridge crossing via a concrete curtain. Accessibility to the stream was moderately difficult due to tall, dense vegetation along the steep stream banks (Figure 5.2). Downstream access was blocked due to a fence that crossed the stream immediately downstream of the State Highway 6 crossing. Deep deposits of sludge were encountered on the streambed that began at the State Highway 6 crossing and ended at the 120-meter transect. Log jams were also encountered along the survey reach (Figure 5.3). Figures 5.2 and 5.3 depict the appearance of the site during each of the surveys. Average thalweg depth was 0.64 meters during the June event and 0.54 meters during the August event. Five pools were identified during the June survey and two were identified during the August survey, most of which were over a meter deep (Tables 5.12 and 5.13).

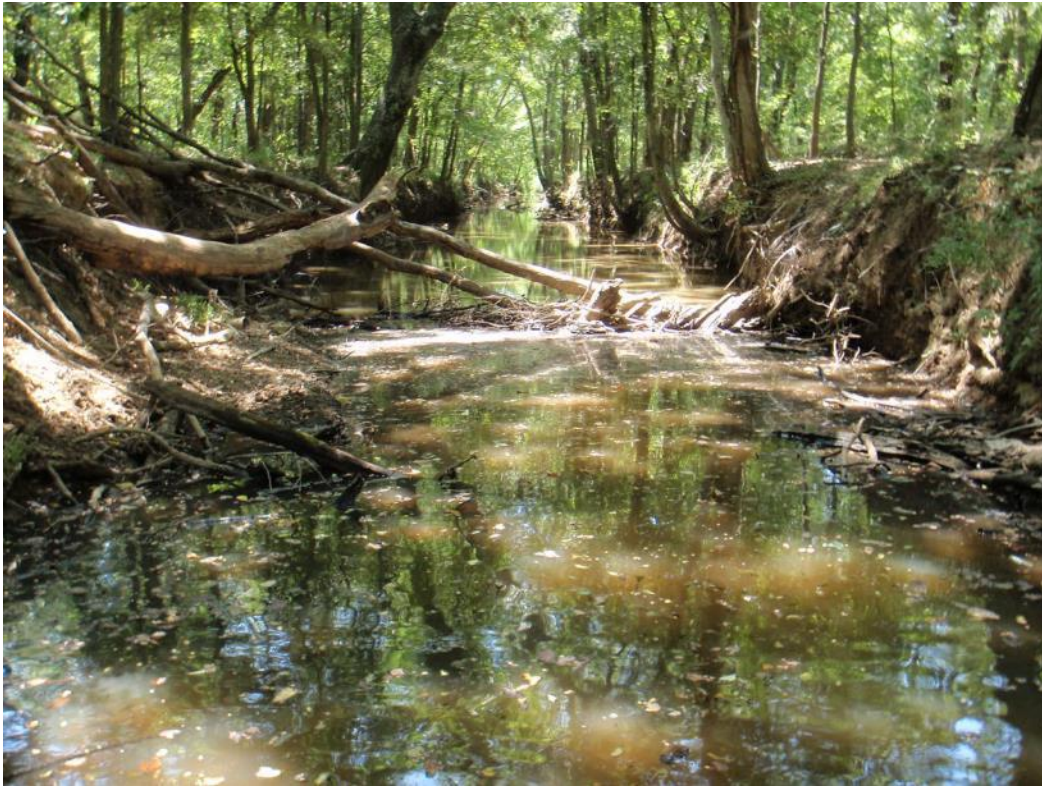
Figure 5.3 Photograph of Mud Creek Site 16402 taken on August 27, 2010, the downstream view of the 300-m transect.

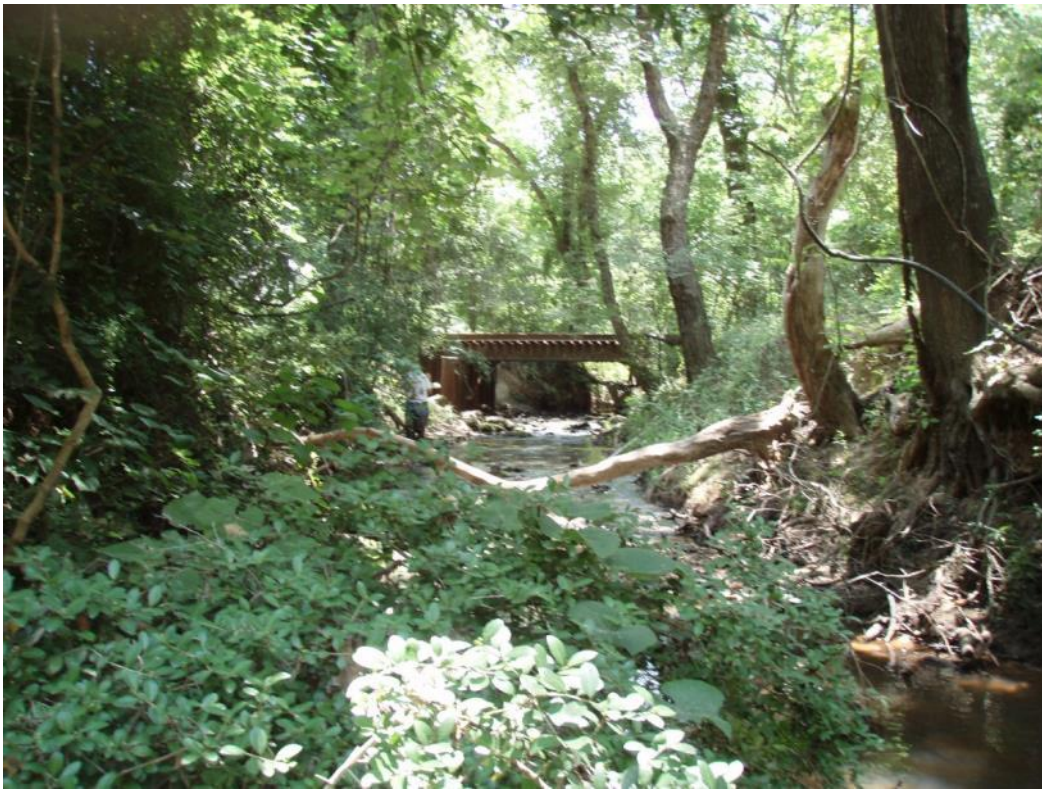
Figure 5.4 Photograph of Mud Creek Site 99906 taken on June 23, 2010, the upstream view of the 30-m transect.

Mud Creek at Site 99906 was visited on June 23 and August 27, 2010. This site is located at Mud Creek Road approximately 3.3 miles east of Calvert, Texas and 2.5 miles upstream of Site 16402. Site 99906 was accessible at the area immediately underneath the bridge crossing. Accessibility to the stream was moderately difficult due to steep, overgrown stream banks. During the August survey large debris piles composed of logs and other woody debris within the stream channel were observed throughout the reach. Figures 5.4 and 5.5 depict the appearance of the site during each of the surveys. Average thalweg depth was 0.46 meters during the June event and 0.32 meters during the August event. Five pools were identified during the June survey (Table 5.14); however, all five were less than 1 m deep. No pools were identified in the August survey.

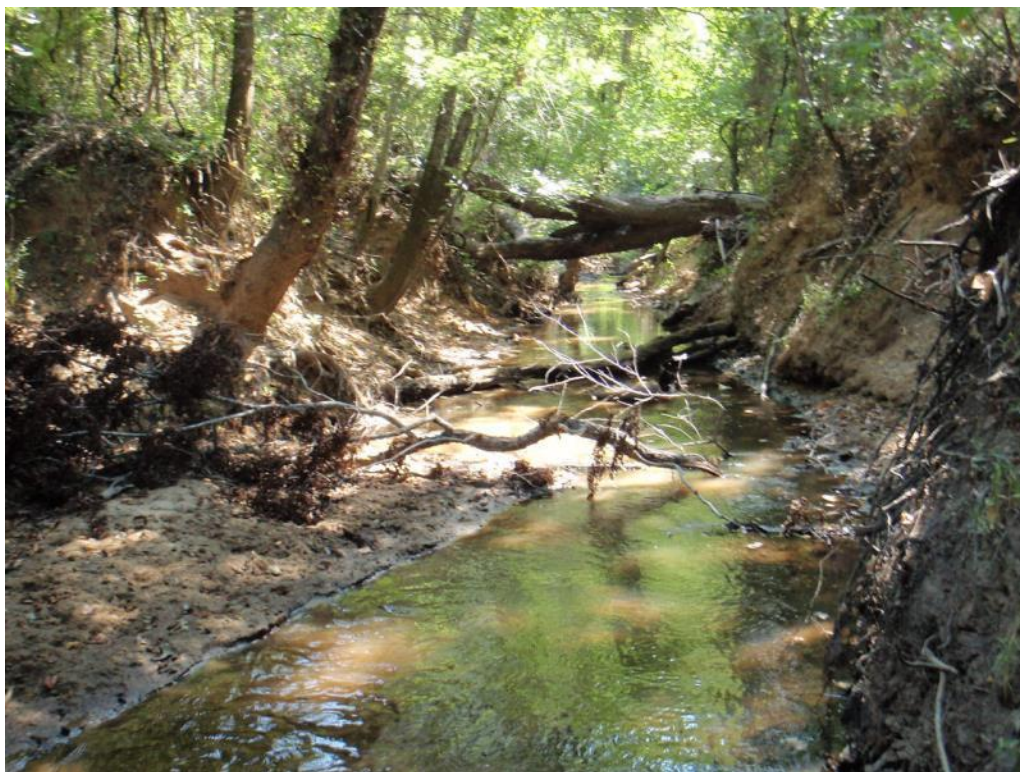
Figure 5.5 Photograph of Mud Creek Site 99906 taken on August 27, 2010, the upstream view of the 300-m transect.

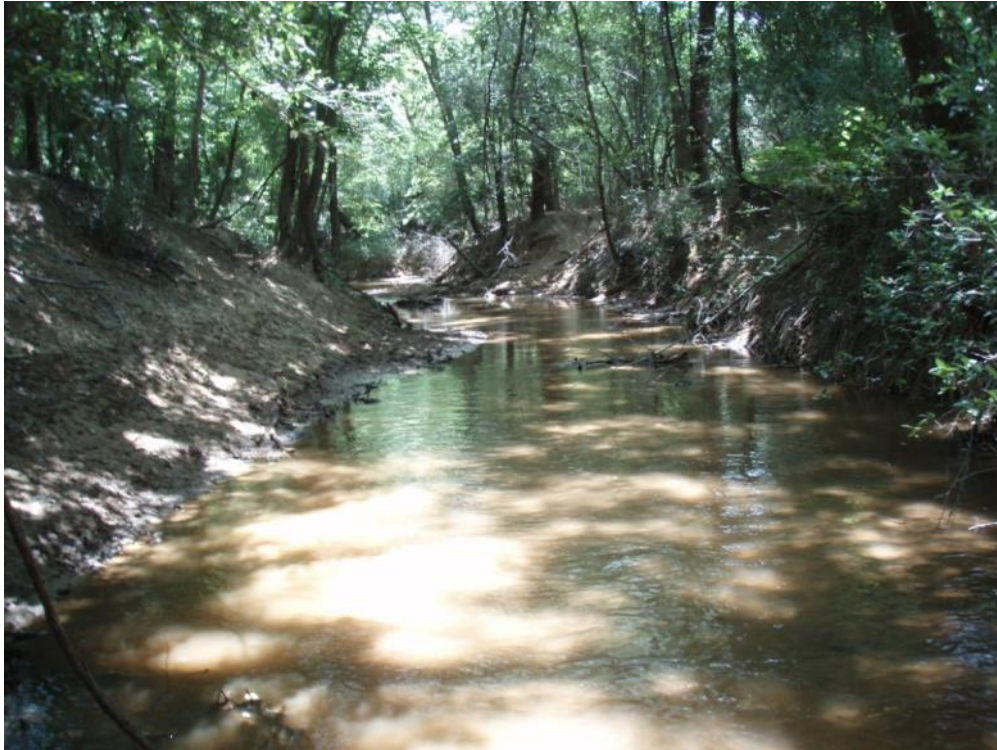
Figure 5.7 Photograph of Mud Creek Site 20562 taken on August 24, 2010, the upstream view of the 30-m transect.

Mud Creek at Site 20562 was visited on June 23 and August 24, 2010. This site is located on Robertson County Road 160 (also known as Jack Brewer Road) approximately 6.3 miles east of Calvert, Texas and 4.4 miles upstream of Site 99906. Site 20562 was accessible at the area immediately underneath the bridge crossing; however, the stream is fenced on the downstream side of the bridge. Accessibility to the stream was moderately difficult due to steep overgrown banks. During the two surveys, rip rap composed mostly of woody debris was encountered within the stream channel at the 30 meter transect. Figures 5.6 and 5.7 depict the appearance of the site during each of the surveys.

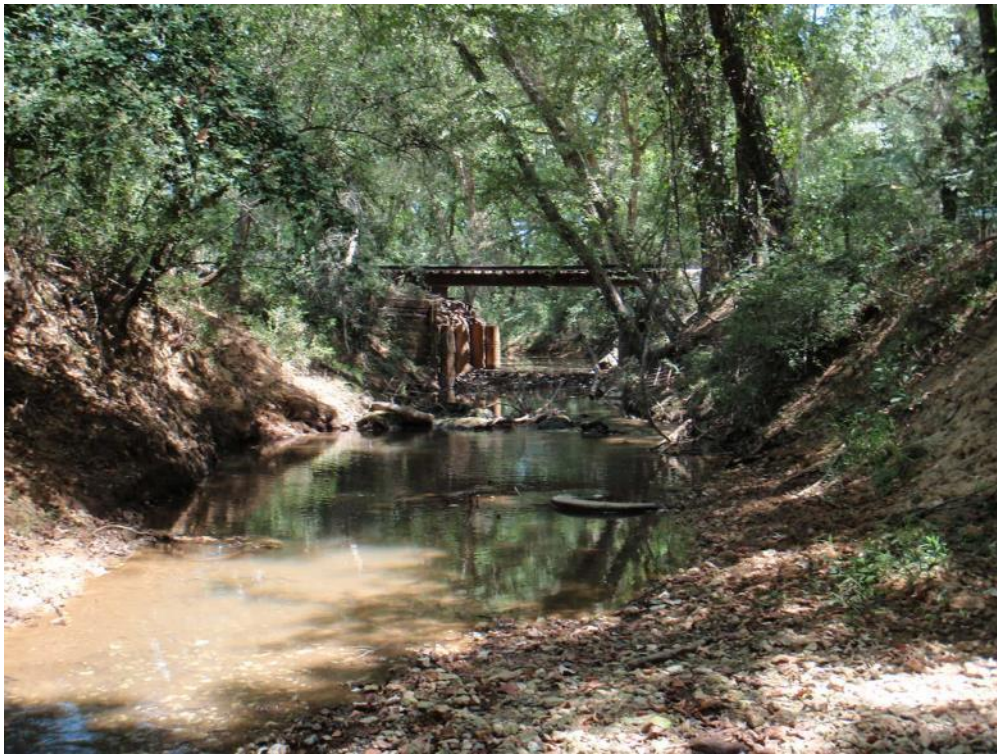
Figure 5.8 Photograph of Mud Creek Site 20562 taken on August 24, 2010, the upstream view of the 30-m transect.

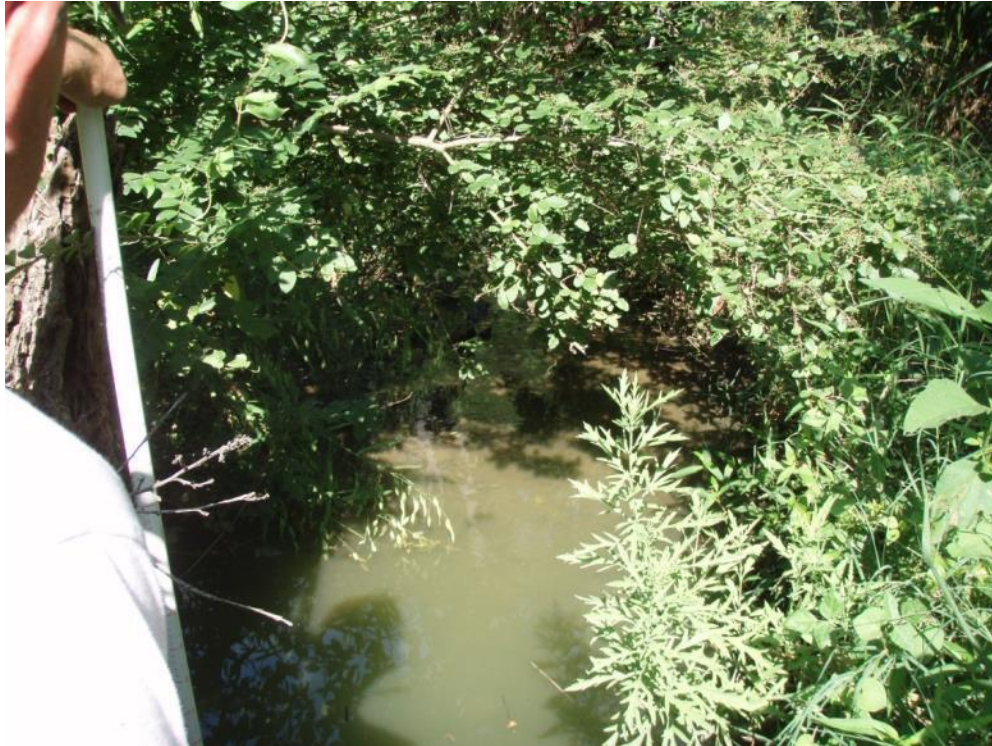
Figure 5.9 Photograph of Mud Creek Site 99907 taken on June 23, 2010, the upstream view of the 300-m transect. BRA personnel in photograph.

Mud Creek at Site 99907 was visited on June 23 and August 27, 2010. This site is located on State Highway 79 approximately 1 mile west of Franklin, Texas, and 5.9 miles upstream of Site 20562. The site is located downstream of the City of Franklin WWTP discharge. Site 99907 was accessible at the area immediately underneath the bridge crossing; however, the stream was fenced off immediately downstream of the bridge crossing. Accessibility to the stream was moderately easy due to the mowed State Highway 79 right-of-way. Log jams within the stream channel and thick vegetation along the banks were encountered during both surveys. Figures 5.9 and 5.10 depict the appearance of the site during each of the surveys. Average thalweg depth was 0.31 meters during the June event and 0.27 meters during the August event. Five pools were identified during the June survey and one was identified during the August survey, all with depths less than 1 meter (Tables 5.17 and 5.18).
